Report No.: VS-TV-1130415-01

Test Report

Specimen :	Infinity-Alto Sax
Company name :	Vecow Co., Ltd.
Company address :	3F., No.10, Jiankang Rd., Zhonghe Dist., New Taipei City 23586, Taiwan

Test Item	Test 1 : Random Vibration Test										
Test Standard	Vibration : MIL-STD-810G Method 514.6, Category 24										
Sample Condition	Operating										
Test Condition	<p>Waveform: Random Wave</p> <p>Frequency Range: (20 ~ 2000) Hz</p> <p>Axial: X · Y · Z Axis</p> <p>Acceleration: 7.7 Grms</p>

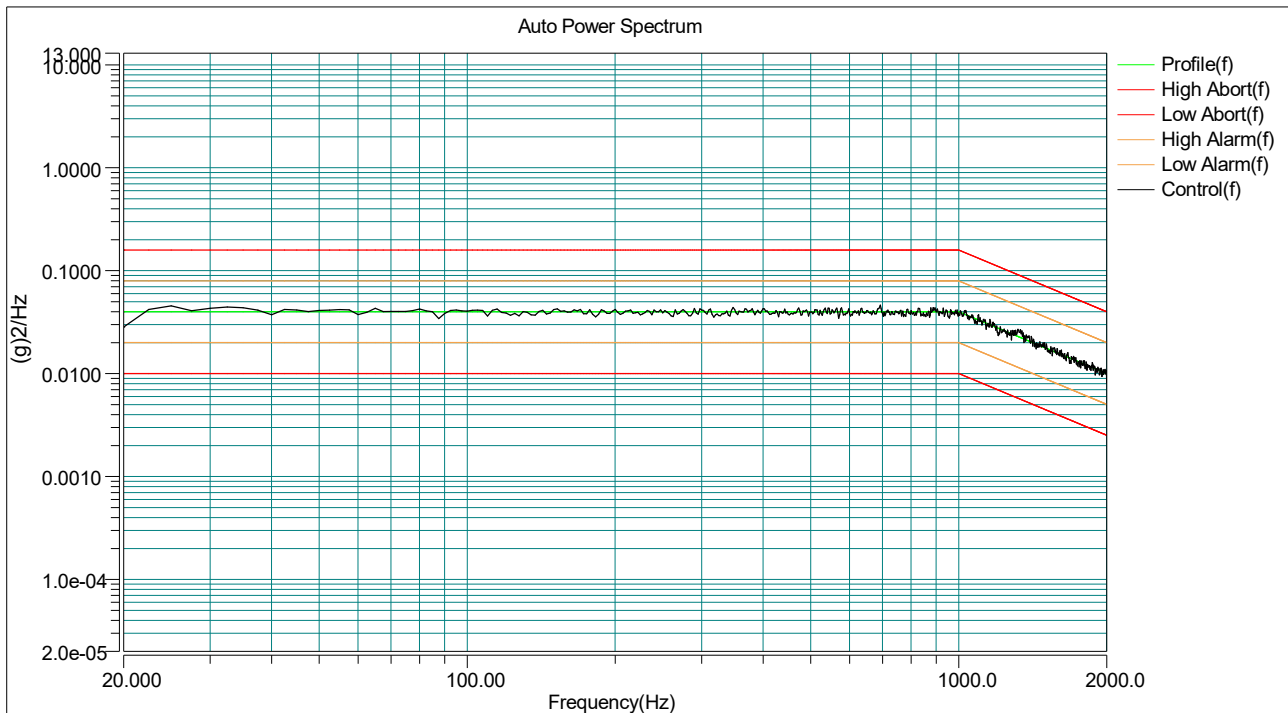
FIG 2: X axis test screen

Current Level: 100 %

Demand RMS: 7.70003 g

Control RMS: 7.70308 g

Test Elapsed: 01:00:20

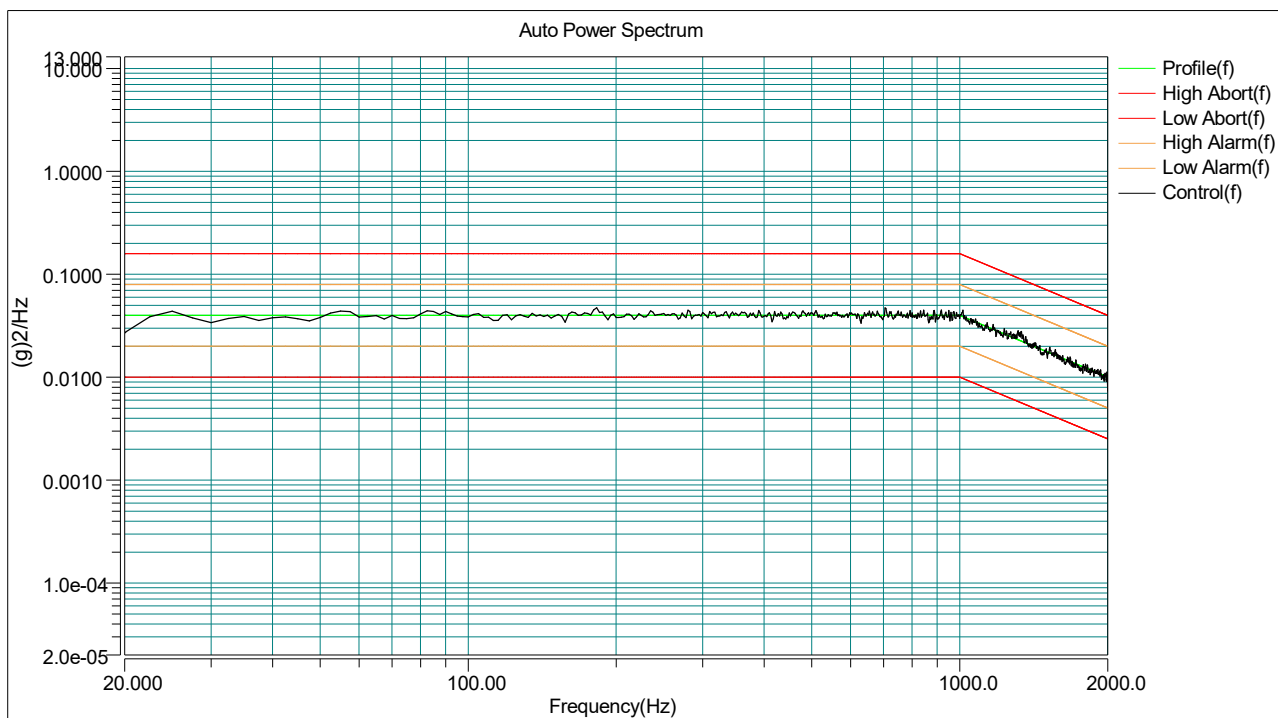
FIG 4: Y axis test screen

Current Level: 100 %

Demand RMS:7.70003 g

Control RMS: 7.72551 g

Test Elapsed:01:00:20

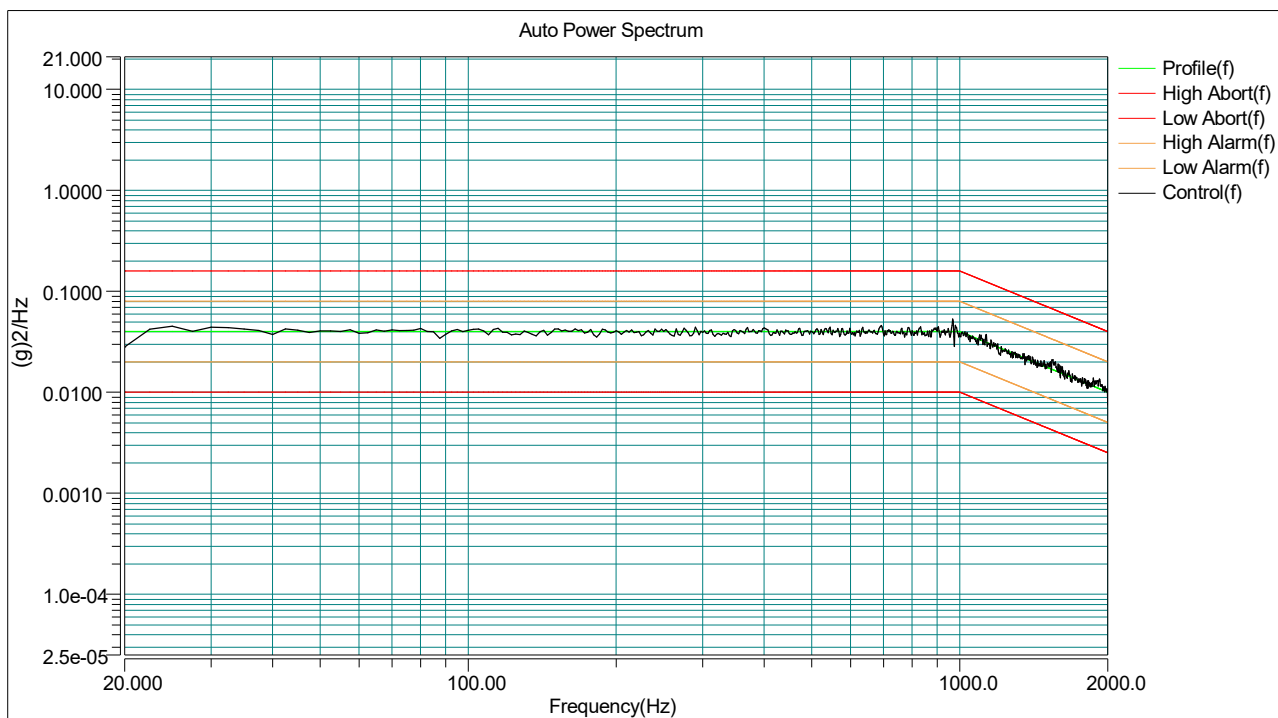
FIG 6: Z axis test screen

Current Level: 100 %

Demand RMS: 7.70003 g

Control RMS: 7.72573 g

Test Elapsed: 01:00:20

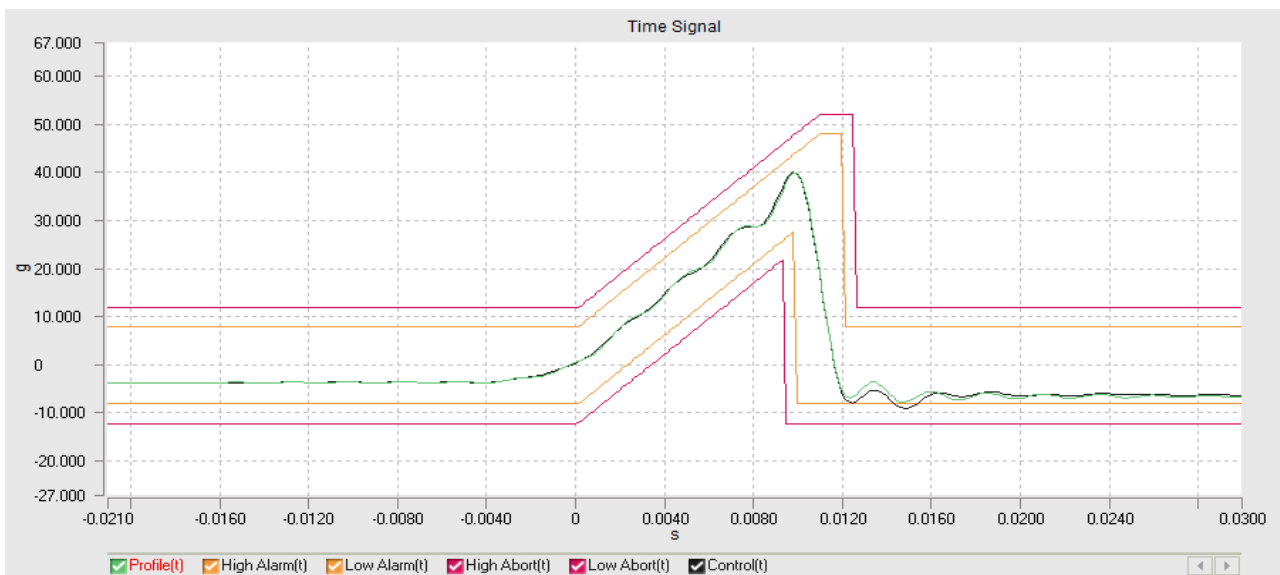
FIG.8 : +X Axis Test screen.

Shock Type:Final Peak Saw Tooth

Mag:40.00 g

Pulse Duration:11 ms

Demand peak: 40.000 g

Control peak:40.112 g

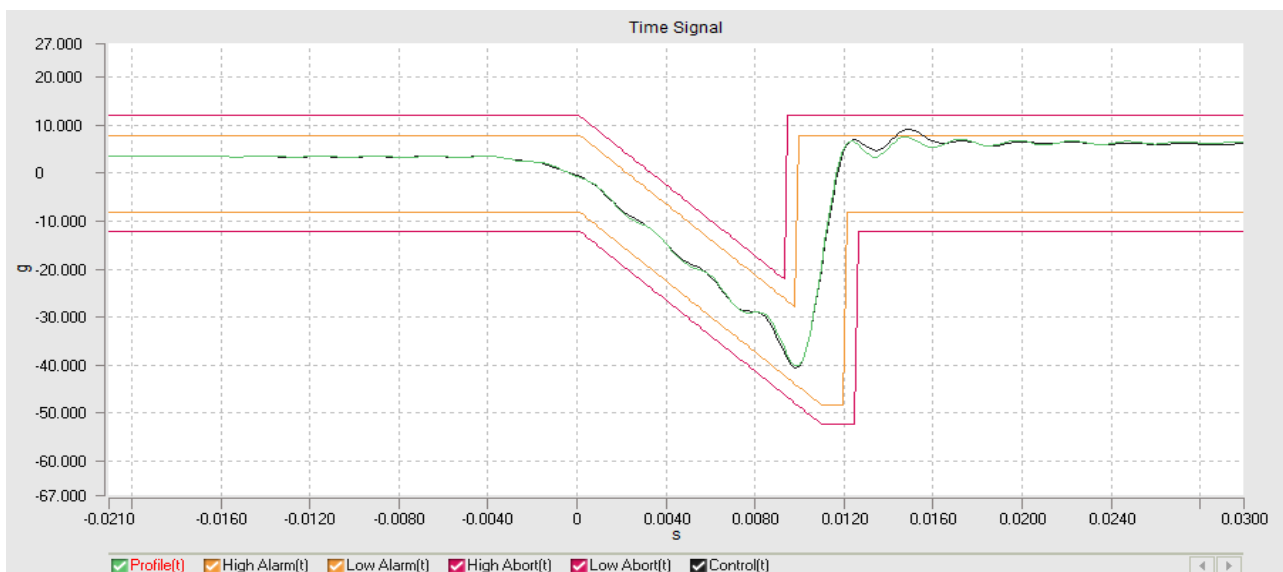
FIG.10 : -X Axis Test screen.

Shock Type:Final Peak Saw Tooth

Mag:40.00 g

Pulse Duration:11 ms

Demand peak: 40.000 g

Control peak:40.340 g

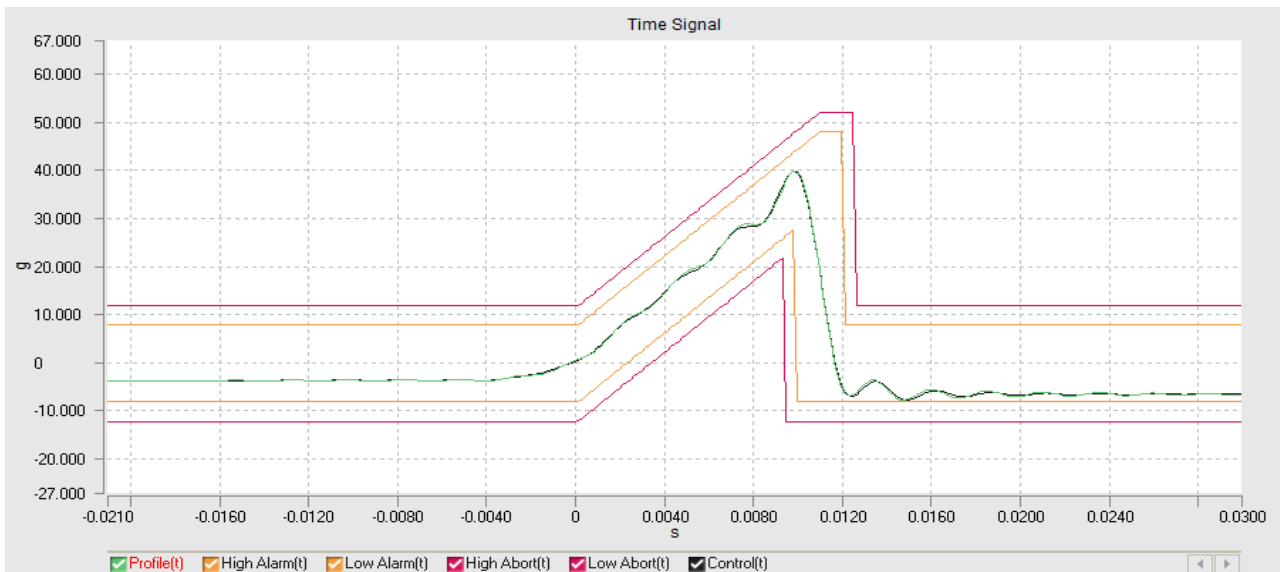
FIG.12 : +Y Axis Test screen.

Shock Type:Final Peak Saw Tooth

Mag:40.00 g

Pulse Duration:11 ms

Demand peak: 40.000 g

Control peak:40.474 g

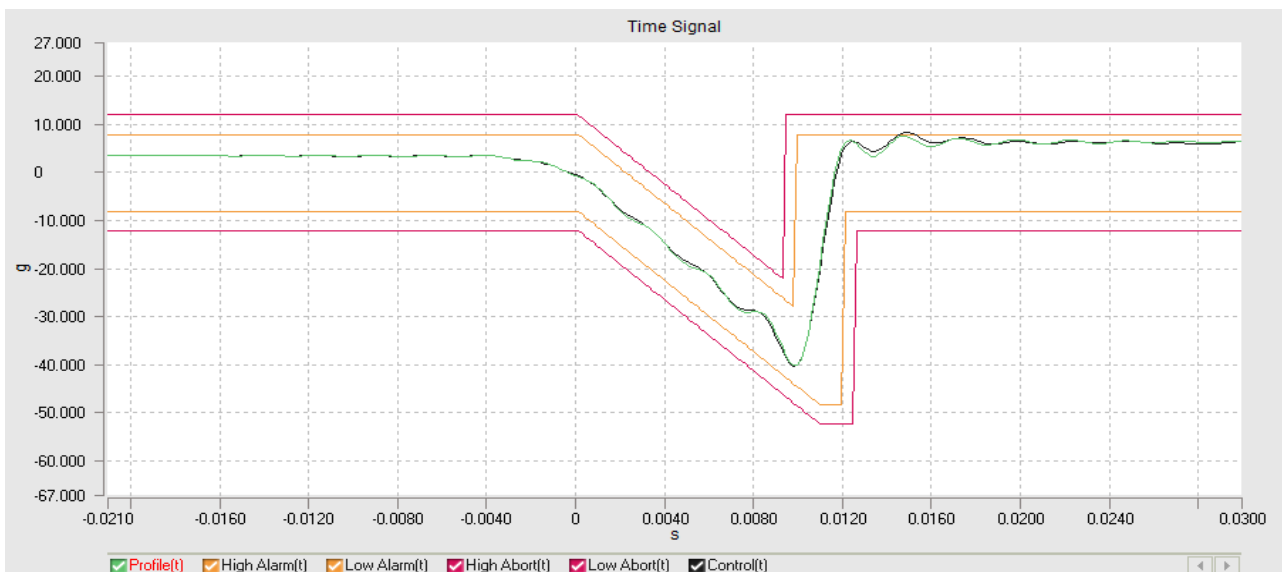
FIG.14 : -Y Axis Test screen.

Shock Type:Final Peak Saw Tooth

Mag:40.00 g

Pulse Duration:11 ms

Demand peak: 40.000 g

Control peak:40.093 g

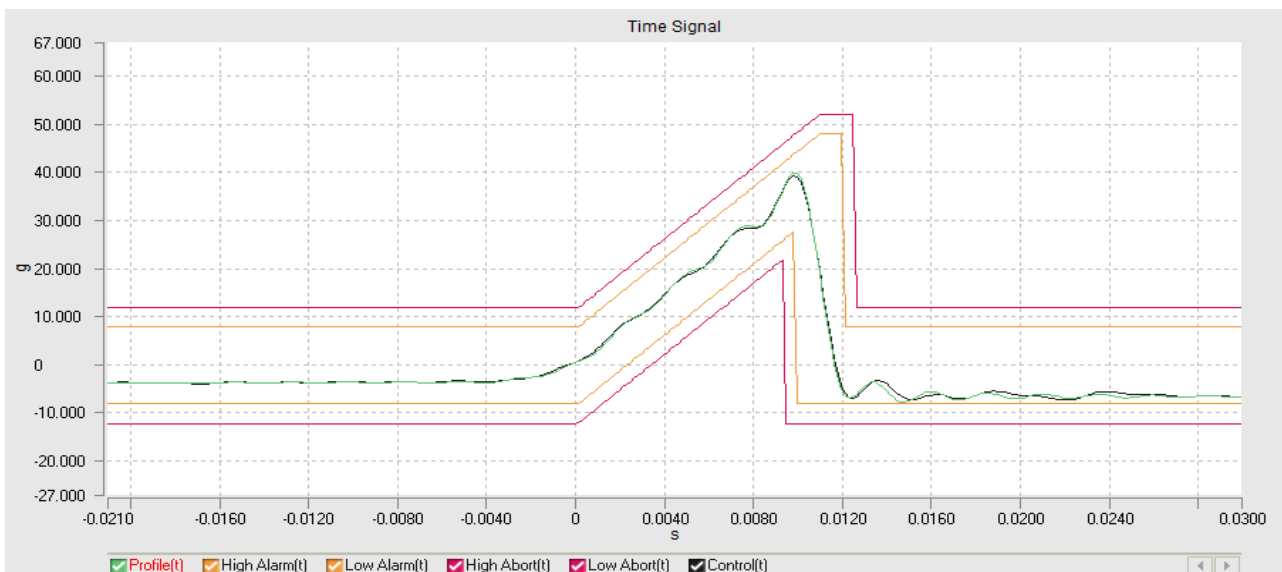
FIG.16 : +Z Axis Test screen.

Shock Type:Final Peak Saw Tooth

Mag:40.00 g

Pulse Duration:11 ms

Demand peak: 40.000 g

Control peak:39.474 g

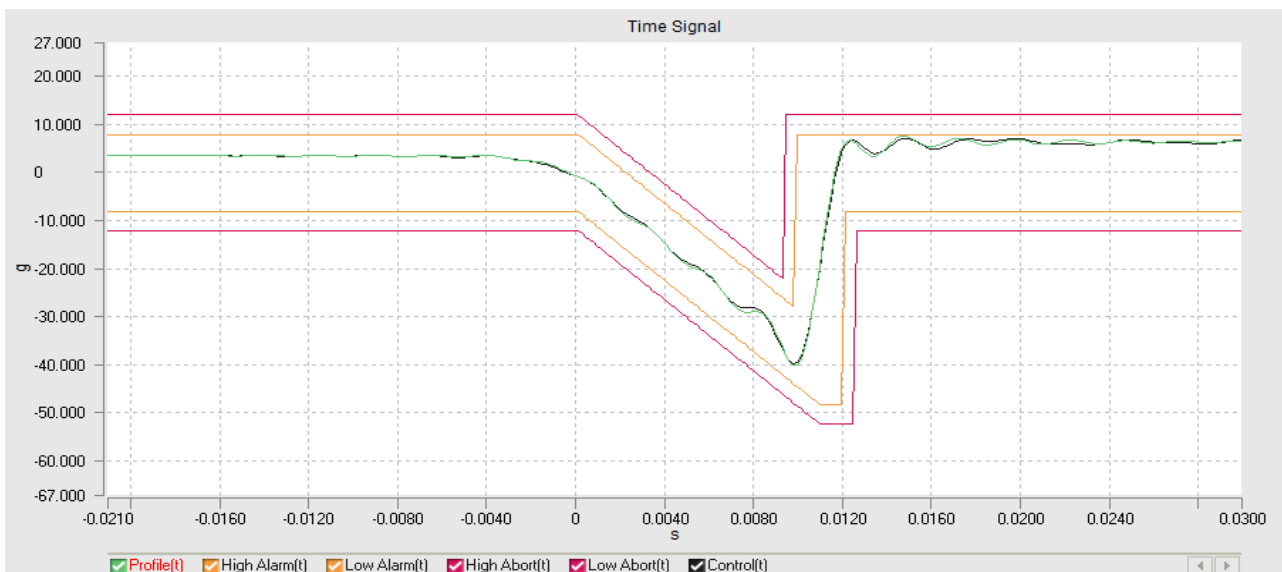
FIG.18 : -Z Axis Test screen.

Shock Type:Final Peak Saw Tooth

Mag:40.00 g

Pulse Duration:11 ms

Demand peak: 40.000 g

Control peak:39.641 g

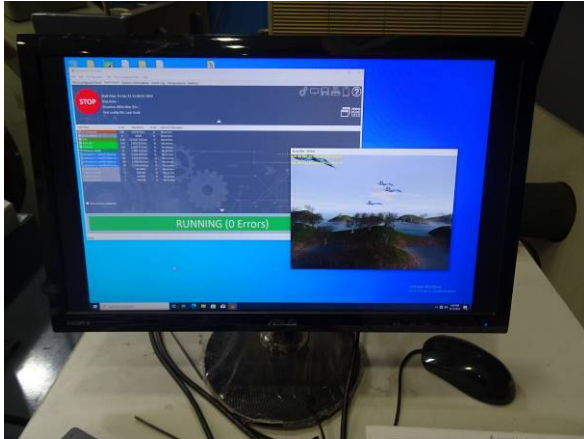
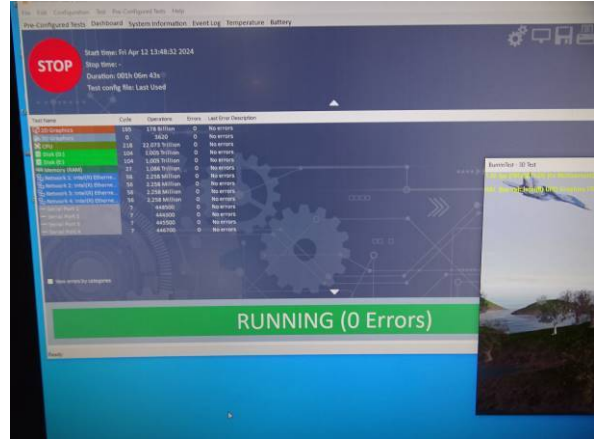
Posterior check.
FIG.19.1 ~ 19.2

Test Result	Appearance: No external physical damage Function: Upon Applicant's comment.	
Test Conducted By		Report Prepared By
Archie Chen <i>Archie Chen</i>		Jane <i>Jane</i>
