# Test Report

Vibration Test  
Mechanical Shock Test  
Temperature Test

**Product name**  
**Expandable AI Computing System**

**Model name**  
**EVS-3100**

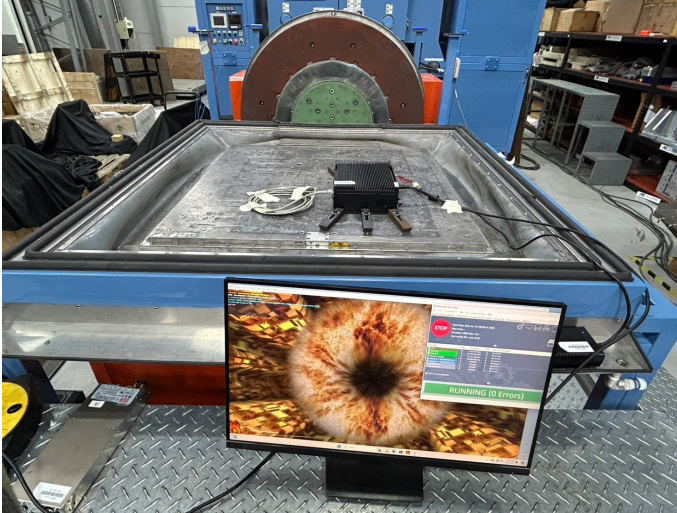
X axis

Setup photo:

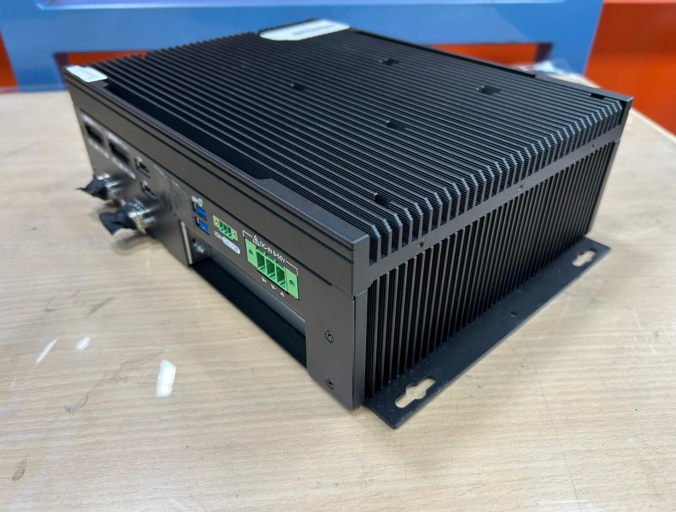
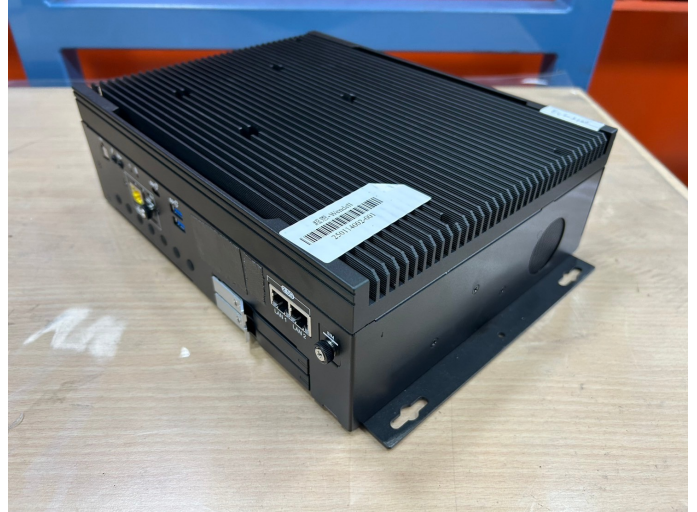
Sample photo after the test:

- No visible damage was found on sample appearance after the test.
- The function was normal after the test.

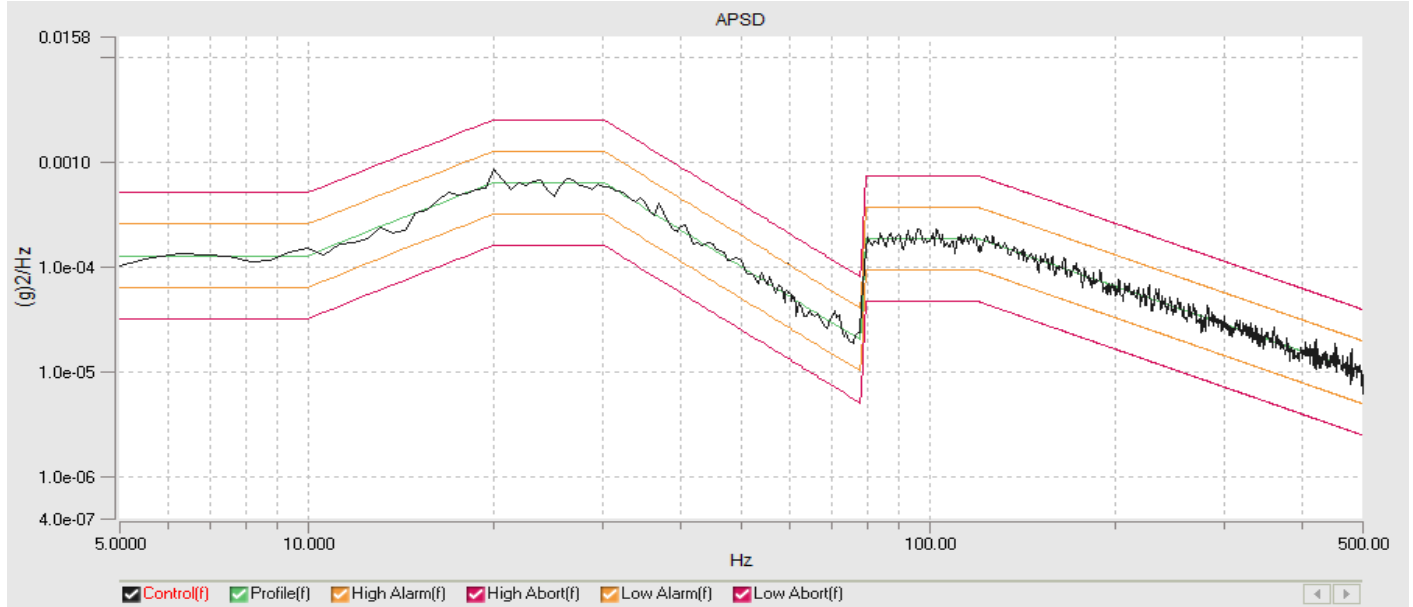
X axis

Demand RMS: 0.205 g

Current Level Time: 01:00:00

Begin Time: 2025-1-20 PM 09:54:00

End Time: 2025-1-20 PM 10:54:48

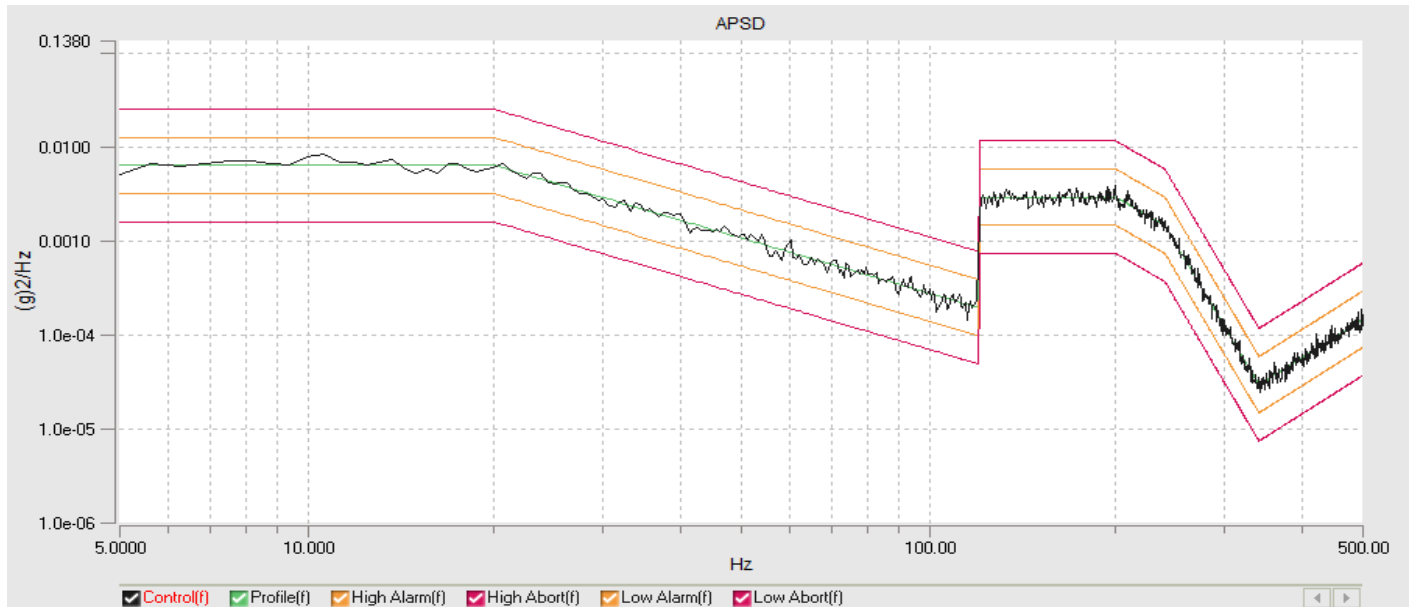
Y axis

Demand RMS: 0.762 g

Current Level Time: 01:00:00

Begin Time: 2025-1-20 PM 08:35:43

End Time: 2025-1-20 PM 09:36:38

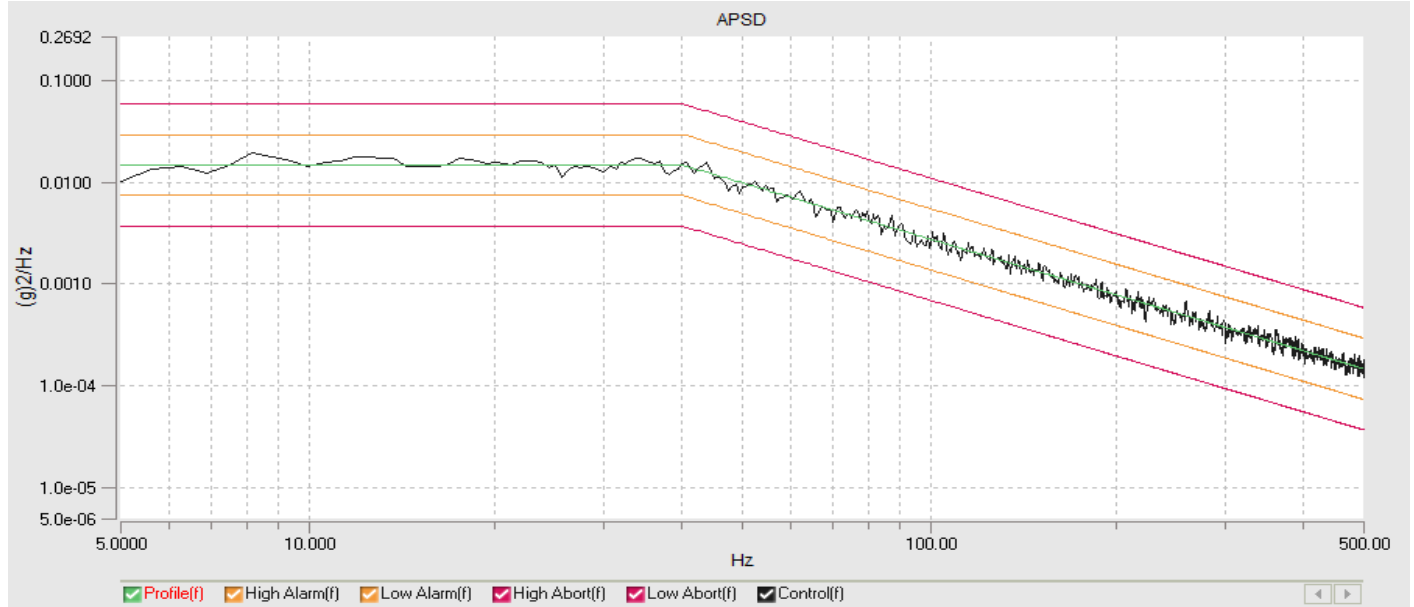
Z axis

Demand RMS: 1.078 g

Current Level Time: 01:00:00

Begin Time: 2025-1-21 PM 07:31:50

End Time: 2025-1-21 PM 08:34:09

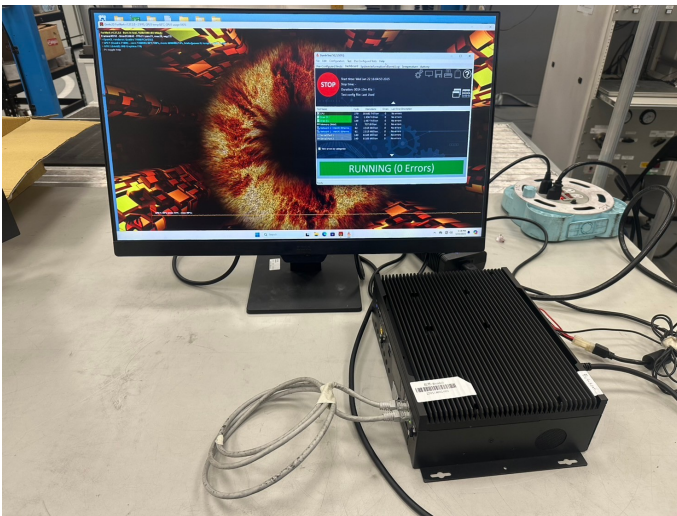
Function check after the test:

- No visible damage was found on sample appearance after the test.
- The function was normal after the test.

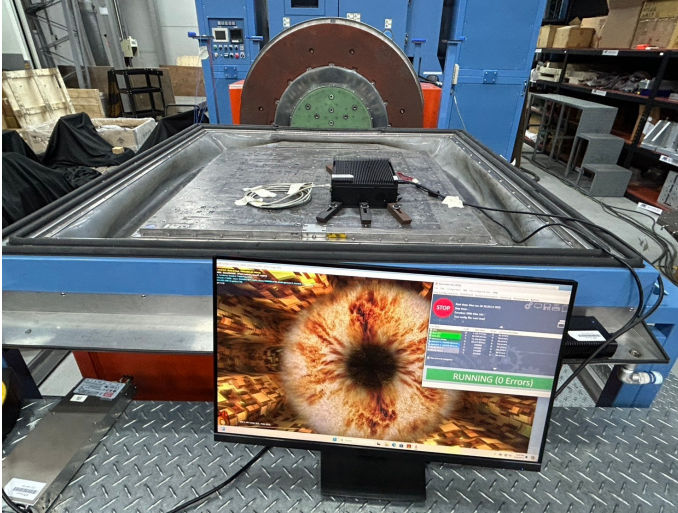
±X axis

Setup photo:

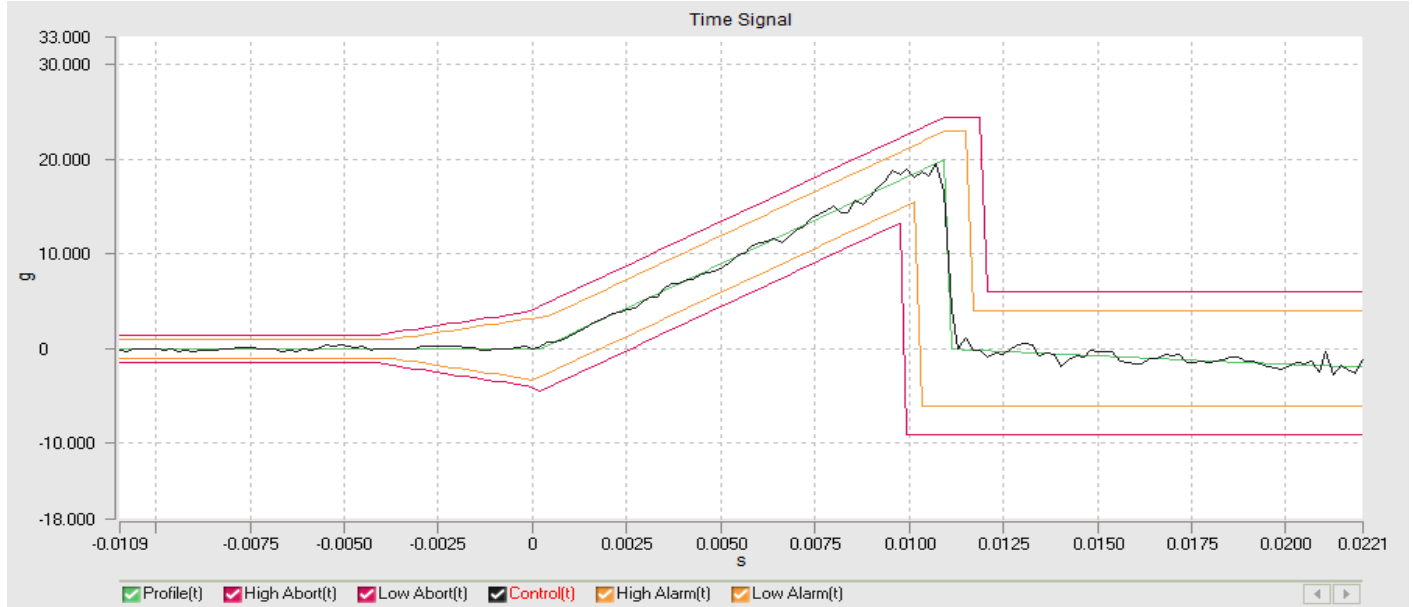
+X axis

Shock Type: Final Peak Saw Tooth

Pulse Duration: 11 ms

Demand peak: 20.000 g

Current Pulses: 3

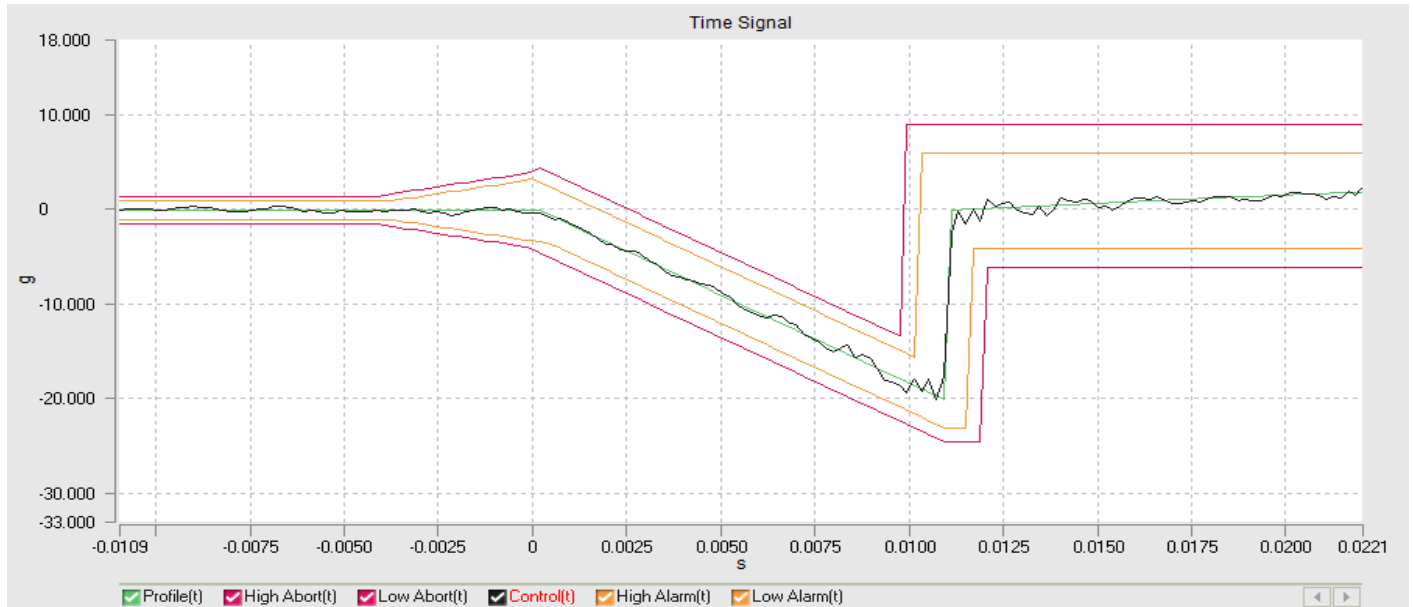
-X axis

Shock Type: Final Peak Saw Tooth

Pulse Duration: 11 ms

Demand peak: 20.000 g

Current Pulses: 3

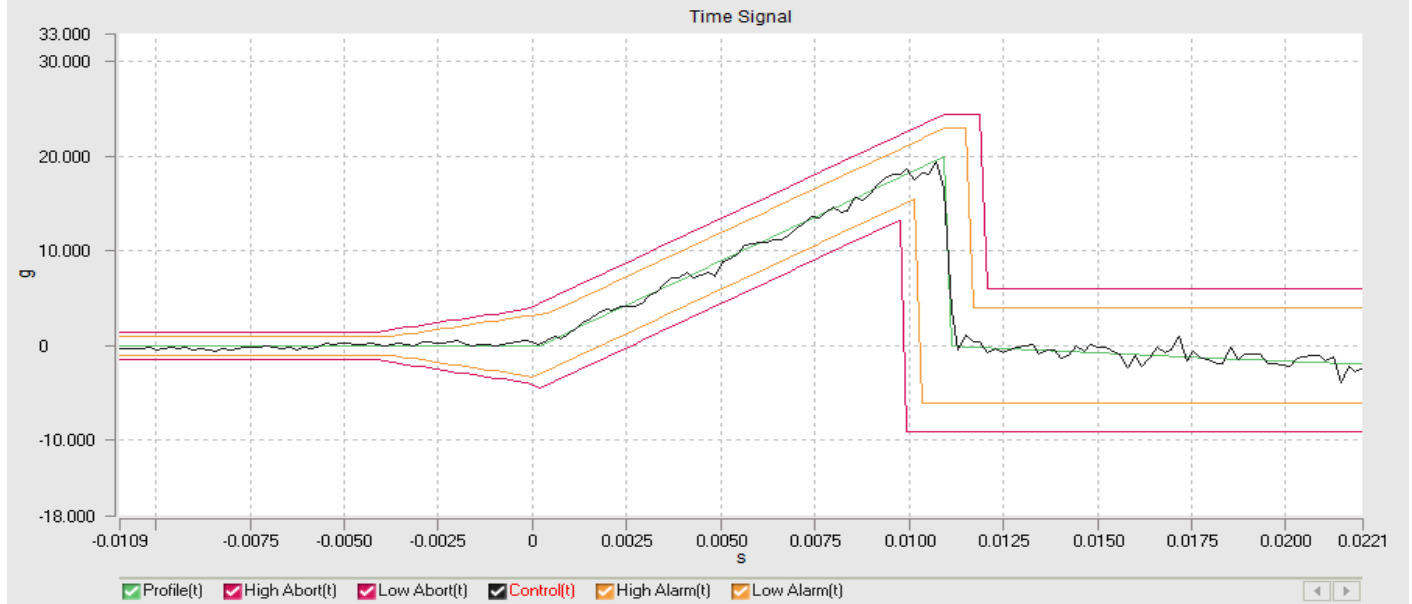
+Y axis

Shock Type: Final Peak Saw Tooth

Pulse Duration: 11 ms

Demand peak: 20.000 g

Current Pulses: 3

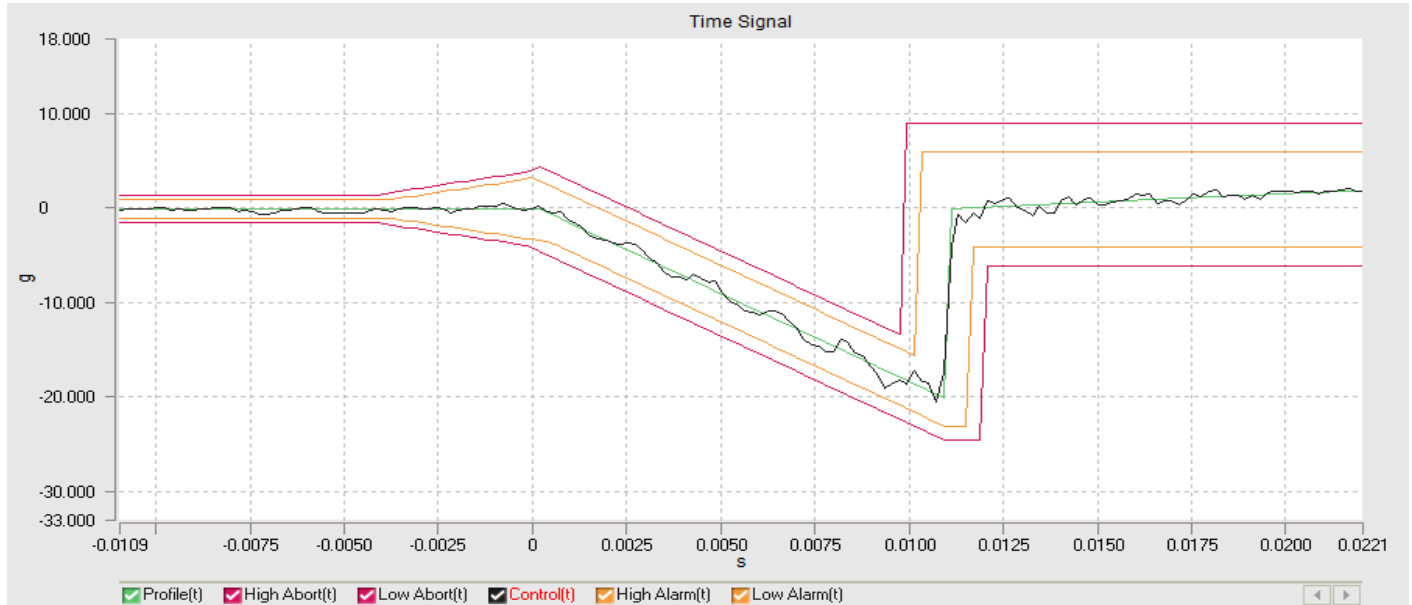
-Y axis

Shock Type: Final Peak Saw Tooth

Pulse Duration: 11 ms

Demand peak: 20.000 g

Current Pulses: 3

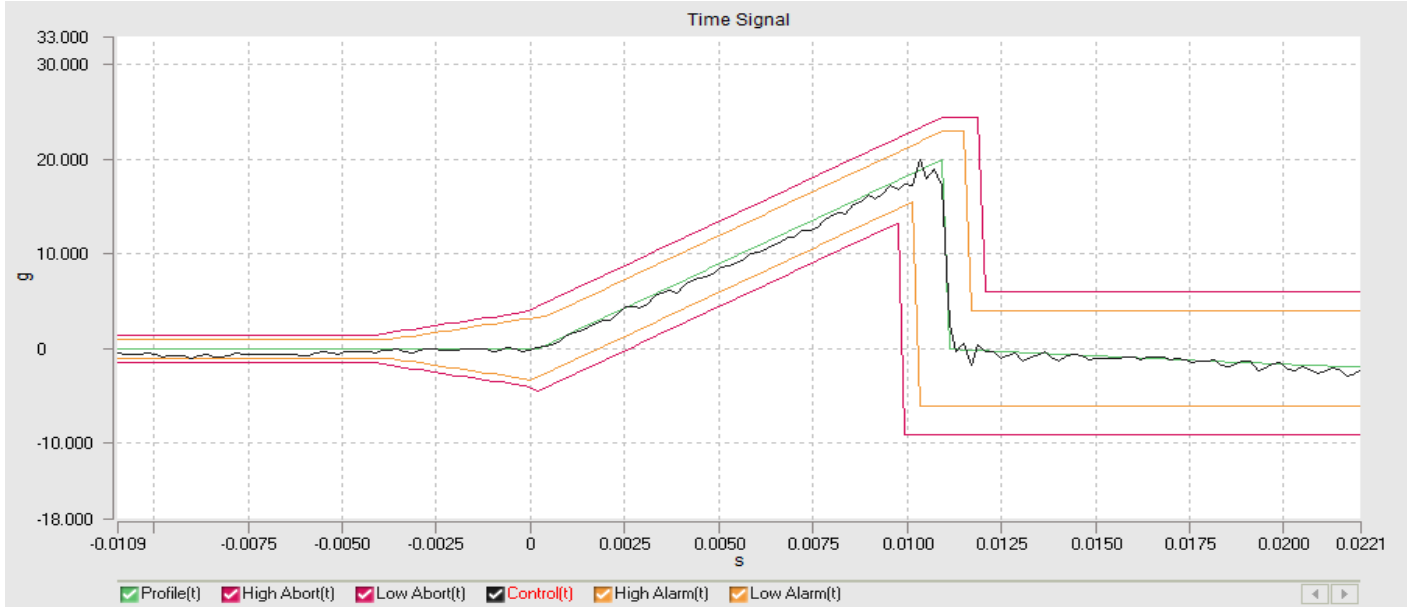
+Z axis

Shock Type: Final Peak Saw Tooth  
Pulse Duration: 11 ms  
Demand peak: 20.000 g  
Current Pulses: 3  
Begin Time: 2025-1-22 PM 06:02:10  
End Time: 2025-1-22 PM 06:04:13

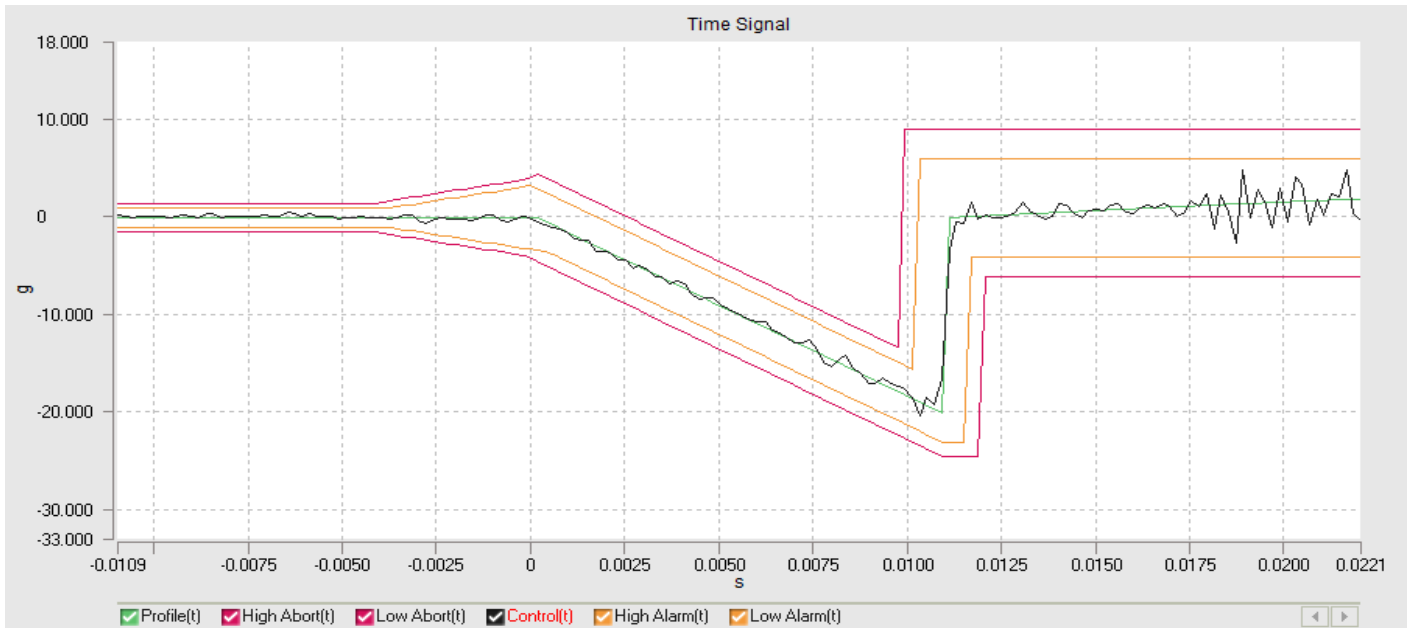
-Z axis

Shock Type: Final Peak Saw Tooth  
Pulse Duration: 11 ms  
Demand peak: 20.000 g  
Current Pulses: 3  
Begin Time: 2025-1-22 PM 06:05:40  
End Time: 2025-1-22 PM 06:07:09

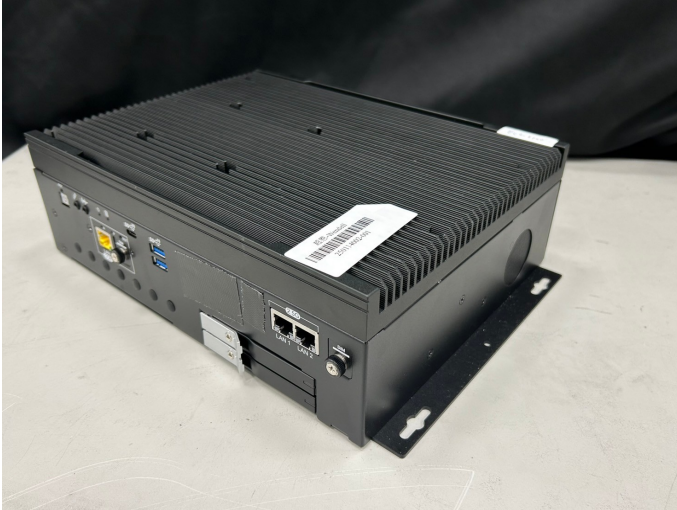
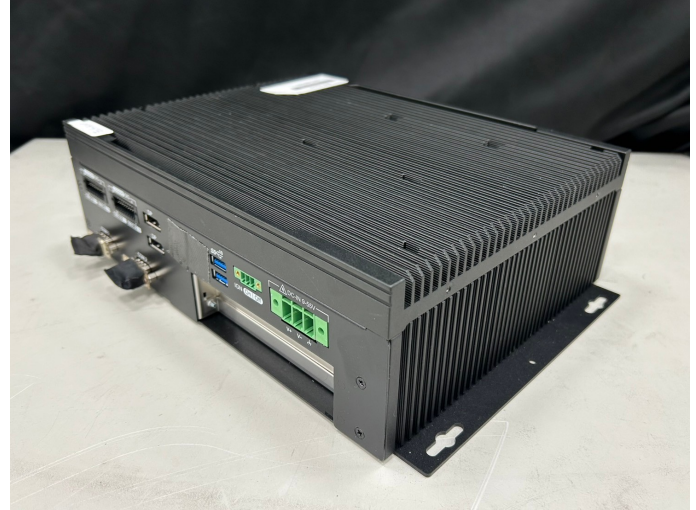
Sample photo after the test:

- No visible damage was found on sample appearance after the test.
- The function was normal after the test.

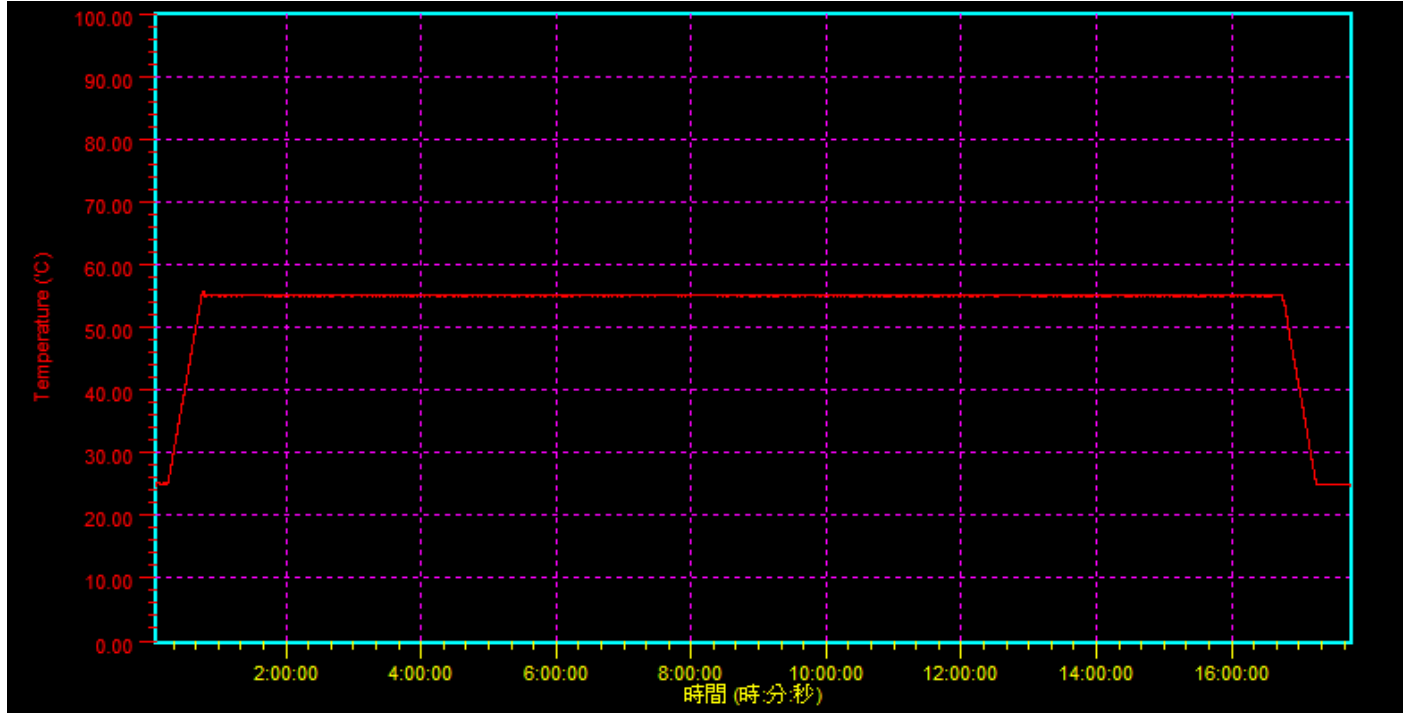
Test 1

曲線	單位	量測值	色彩	時間: 18:49:15
<input checked="" type="checkbox"/> 1. Temperature	°C	-25.085	—

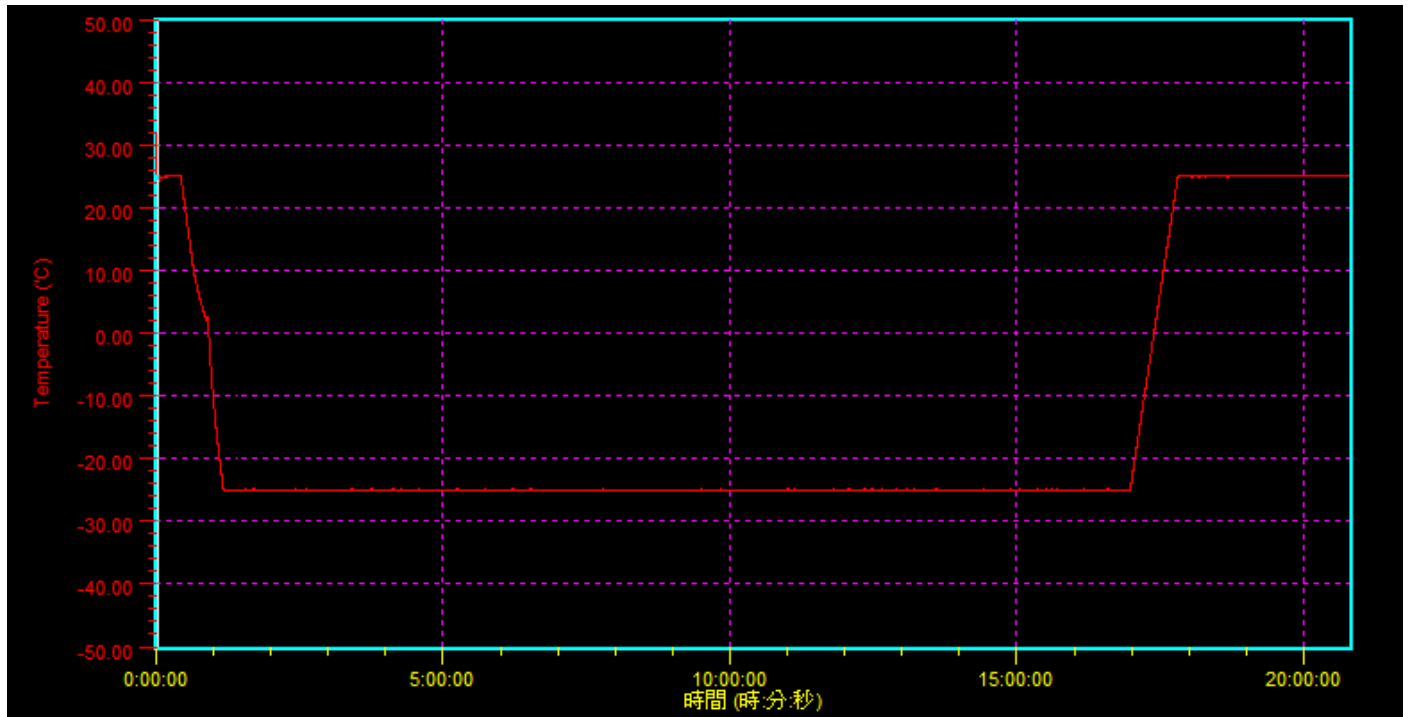
Test 2

曲線	單位	量測值	色彩	時間: 0:01:52
<input checked="" type="checkbox"/> 1. Temperature	°C	24.884	—
